Notice of Intent to Sue AES Corporation (and local affiliates) for RE: Violations of the Resource Conservation and Recovery Act Involving Uncontrolled Disposal of Coal Ash Waste Generated at the AES Coalfired Power Plant in Guayama, Puerto Rico

Appendix A - Locations and Photographs of AES Coal Ash Waste Disposal Sites in and Around Guayama, Puerto Rico

APPENDIX B MAPS SHOWING COAL ASH DISPOSAL LOCATIONS

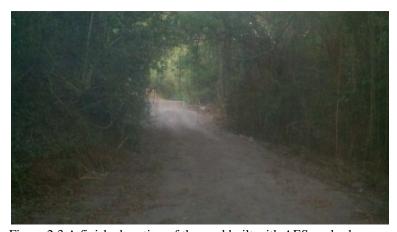
Figure 2.3 A finished section of the road built with AES coal ash.

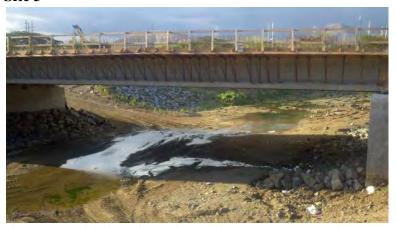
- o Latitude/Longitude: 17.96057754, -66.13589823
 - o Site 3 consists of construction of a new bridge over the Guamaní River to replace an existing old one using AES coal ash as base fill over which a section of approximately 200 meters of State Road PR-3 will be built after the bridge in order to improve the existing sharp turn. This project is being built by the Puerto Rico Roads Authority (Autoridad de Carreteras de Puerto Rico).

Figure 3.1 Partial view of the bridge built over the Guamaní River – south to north with AES coal ash visible in the riverbed.
